The information contained in this document is meant to clarify the parts supplying history, and various aspects of the manufacturing processes used in the production of the crankshaft removed from the #6 Rockstar Makita Suzuki ridden by Mat Mladin following the completion of the Superbike race August 17, 2008.

Part Supply History

Re: GSXR-1000 Crankshaft P/N 12000-41820-000 and FIM E11 part code 12220-41G00 Expert Opinion

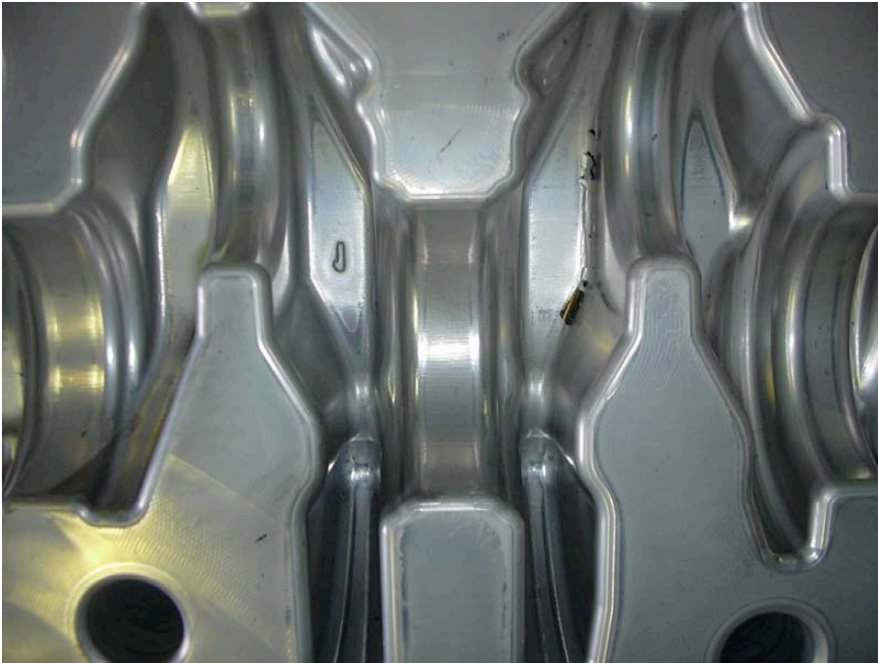
Fig. 1 Condition of new forging dies

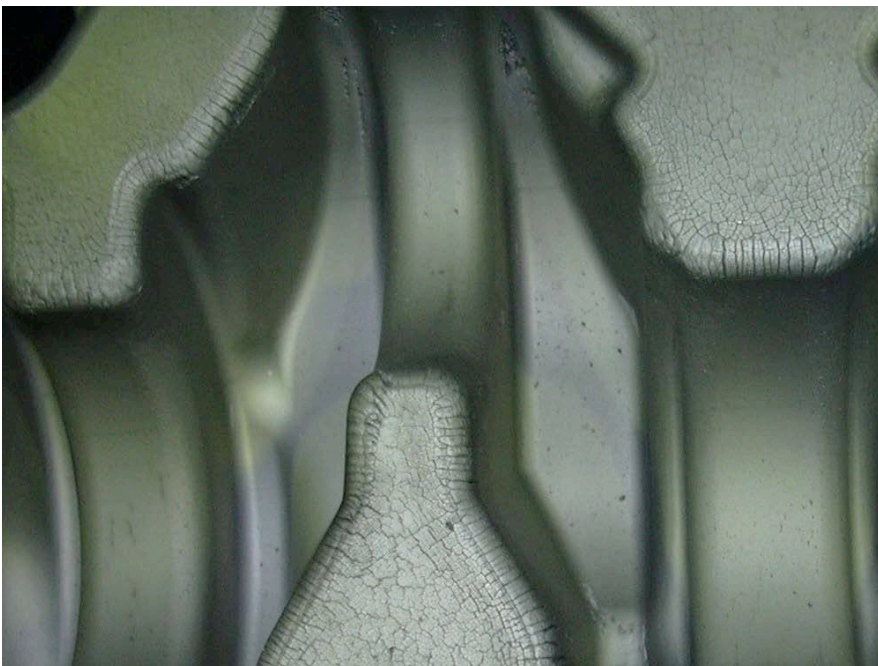
Fig.2 Condition of used forging die

As seen in Fig. 2 the surface finish of the forging die develops a “texture” through normal usage, this “texture” will be transferred to the forging which will result in changes to the surface finish of the crankshafts produced during different stages of the forging die’s life span.

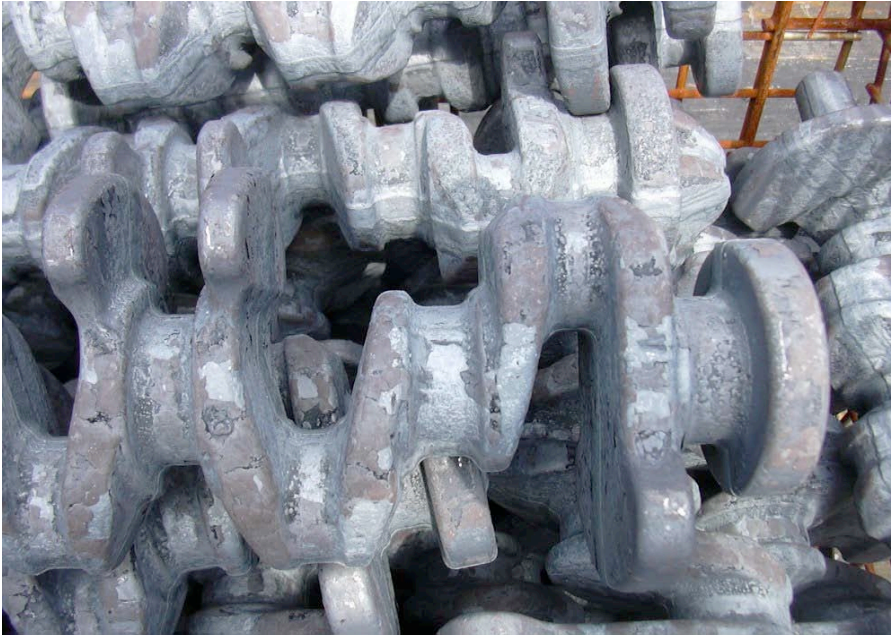
Fig. 3 Raw forging prior to cleaning

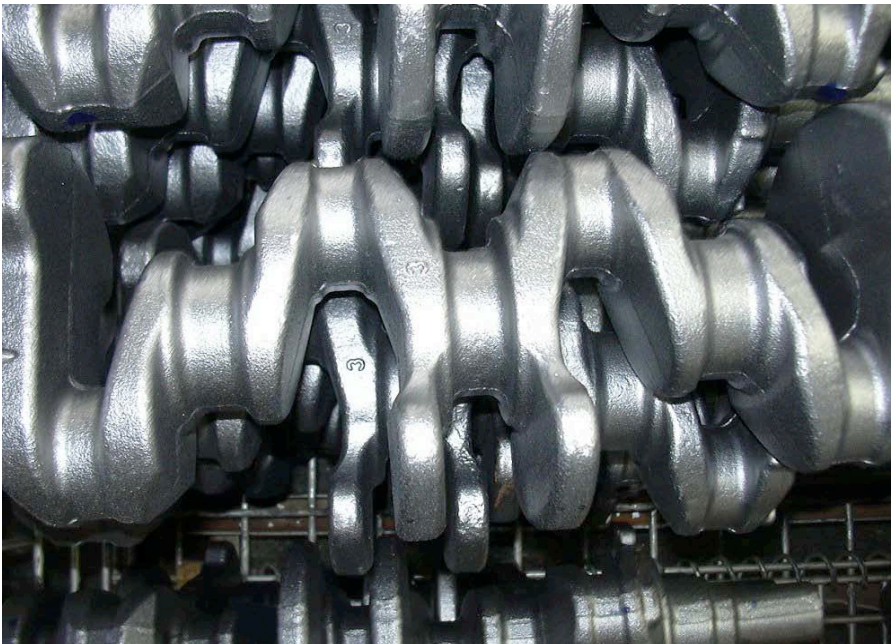
In addition to the surface condition of the forging die described above, another factor affecting the surface appearance of the crankshaft can result from the initial cleaning process applied to the crankshaft forging. Following the initial forging process the crankshaft surface is covered with a type of “flashing” (See Fig. 3) which must be removed. One type of cleaning method used by Kakuta Iron Works is called “shot peening”. It is a type of blasting to remove the “flashing.” Fig. 4 shows examples of the crankshafts following this process. As can be seen in Fig.4, this kind of blast cleaning can cause the rough appearance found in many areas of the finished crankshaft. Differences in blast media and air pressures used in the cleaning process can also result in minor variances in surface finish of the crankshaft.

Fig. 4 Forgings after “blast” cleaning
